## Modine Technical Service Bulletin

Subject: Safety issue when separated combustion gas-fired heaters are used in conjunction with a failed vent system

Date: January 2019

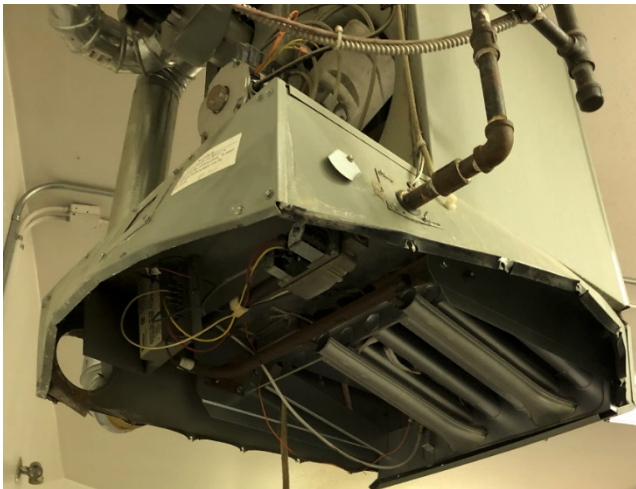
Modine has become aware of a potentially serious safety issue when separated combustion gas-fired heaters are used in conjunction with a failed vent system. Specifically, when the vent system is allowing products of combustion to be recirculated back into the fresh air pipe, there is potential for a severe delayed ignition which could lead to damage to the unit, damage to the unit casing, and even the bottom access panel being separated from the unit and falling to the floor. Modine has not been made aware of any injuries caused by this condition. Note that vent pipe and most other venting components are supplied by others.

Figure 1: Damaged unit heater Potentially caused by failed Vent System

All Modine separated combustion heating units and their vent systems must be inspected. Modine recommends shutting all heating units down until the vent systems are inspected and verified to be working correctly.

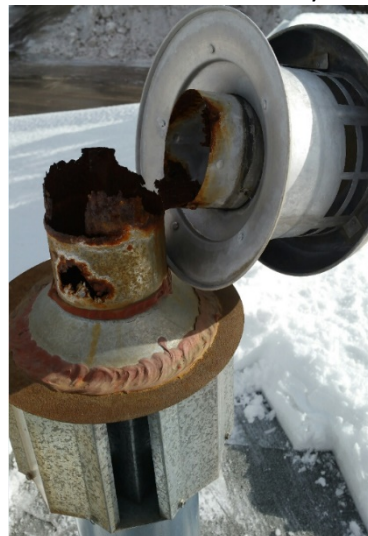
Figure 2: Failed Concentric Vent System

Modine has extensively reviewed documentation from numerous sites. Among the items common to these sites is a concentric vent where the product of combustion (exhaust) was allowed to recirculate back into the combustion air pipe (fresh air).

**Vent designs must be reviewed:** (a) for ways to reduce the chance of recirculation of products of combustion (concentric or otherwise) and (b) to make sure equivalent vent lengths are within Modine requirements. Recommended venting arrangements may be found in the Installation and Service Manuals available on [www.ModineHVAC.com](http://www.ModineHVAC.com).

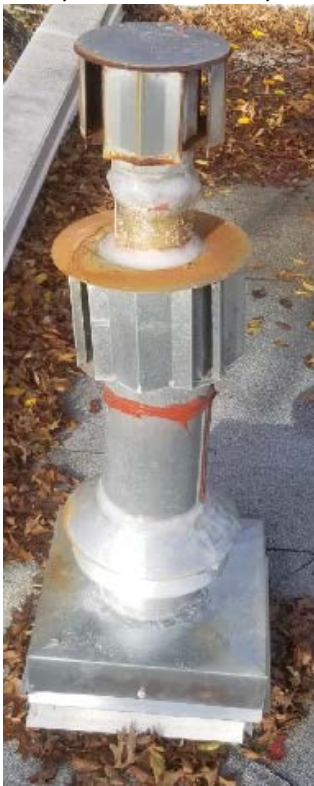
**Inspections must be performed on all vent systems to make sure they are in proper working order.** Figure 3 shows that visual inspection of concentric vents is not adequate to determine if the vent is working properly. Figure 4 shows the vent system from Figure 3 upon further inspection. Vent caps must be removed to inspect the inner pipe and ensure it has no breaches. Two-pipe systems should also be reviewed to ensure recirculation of products of combustion is not possible. Preventive maintenance is required on all gas fired appliances. At least annual inspection of vents on all gas appliances is best practice.

Figure 3: Visual Inspection of Vent Pipe is **NOT Sufficient**.

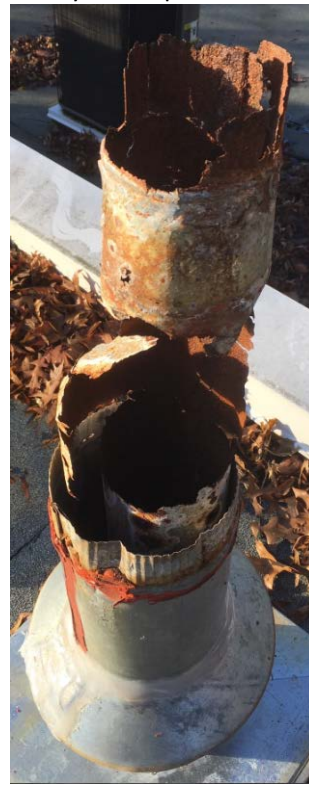
Figure 4: Vent System Upon Further Inspection
